**CULTURAL RESOURCE ASSESSMENT SURVEY
IN SUPPORT OF STATE ROAD 16 PONDS,
ST. JOHNS COUNTY, FLORIDA**

CONSULTANT:	SEARCH 8298 Bayberry Road #1, Jacksonville, FL 32256
PRINCIPAL INVESTIGATOR:	Kristina Altes, PhD, RPA
ARCHITECTURAL HISTORIAN:	Kate Willis, MPS
PROJECT ARCHAEOLOGIST:	Matthew Mele, BA
CLIENT:	Florida Department of Transportation, District 2
DATE:	May 2024
FM #:	210447-5-32-01
SEARCH PROJECT #:	230292

This report details the results of a cultural resource assessment survey (CRAS) of three preferred pond locations and one easement/flood compensation area in St. Johns County, Florida. The Florida Department of Transportation (FDOT), District 2, is proposing to construct three stormwater ponds associated with improvements along State Road (SR) 16 in St. Johns County, Florida (**Figure 1**). This report serves as an addendum to the previous CRAS report titled *Cultural Resource Assessment Survey for State Road 16 from International Golf Parkway to I-95, St. Johns County, Florida* completed by SEARCH in 2024 (Mele et al. 2024). The total area tested for the current survey is 54.2 acres (ac). The discussions of regional precontact and postcontact history and research design r

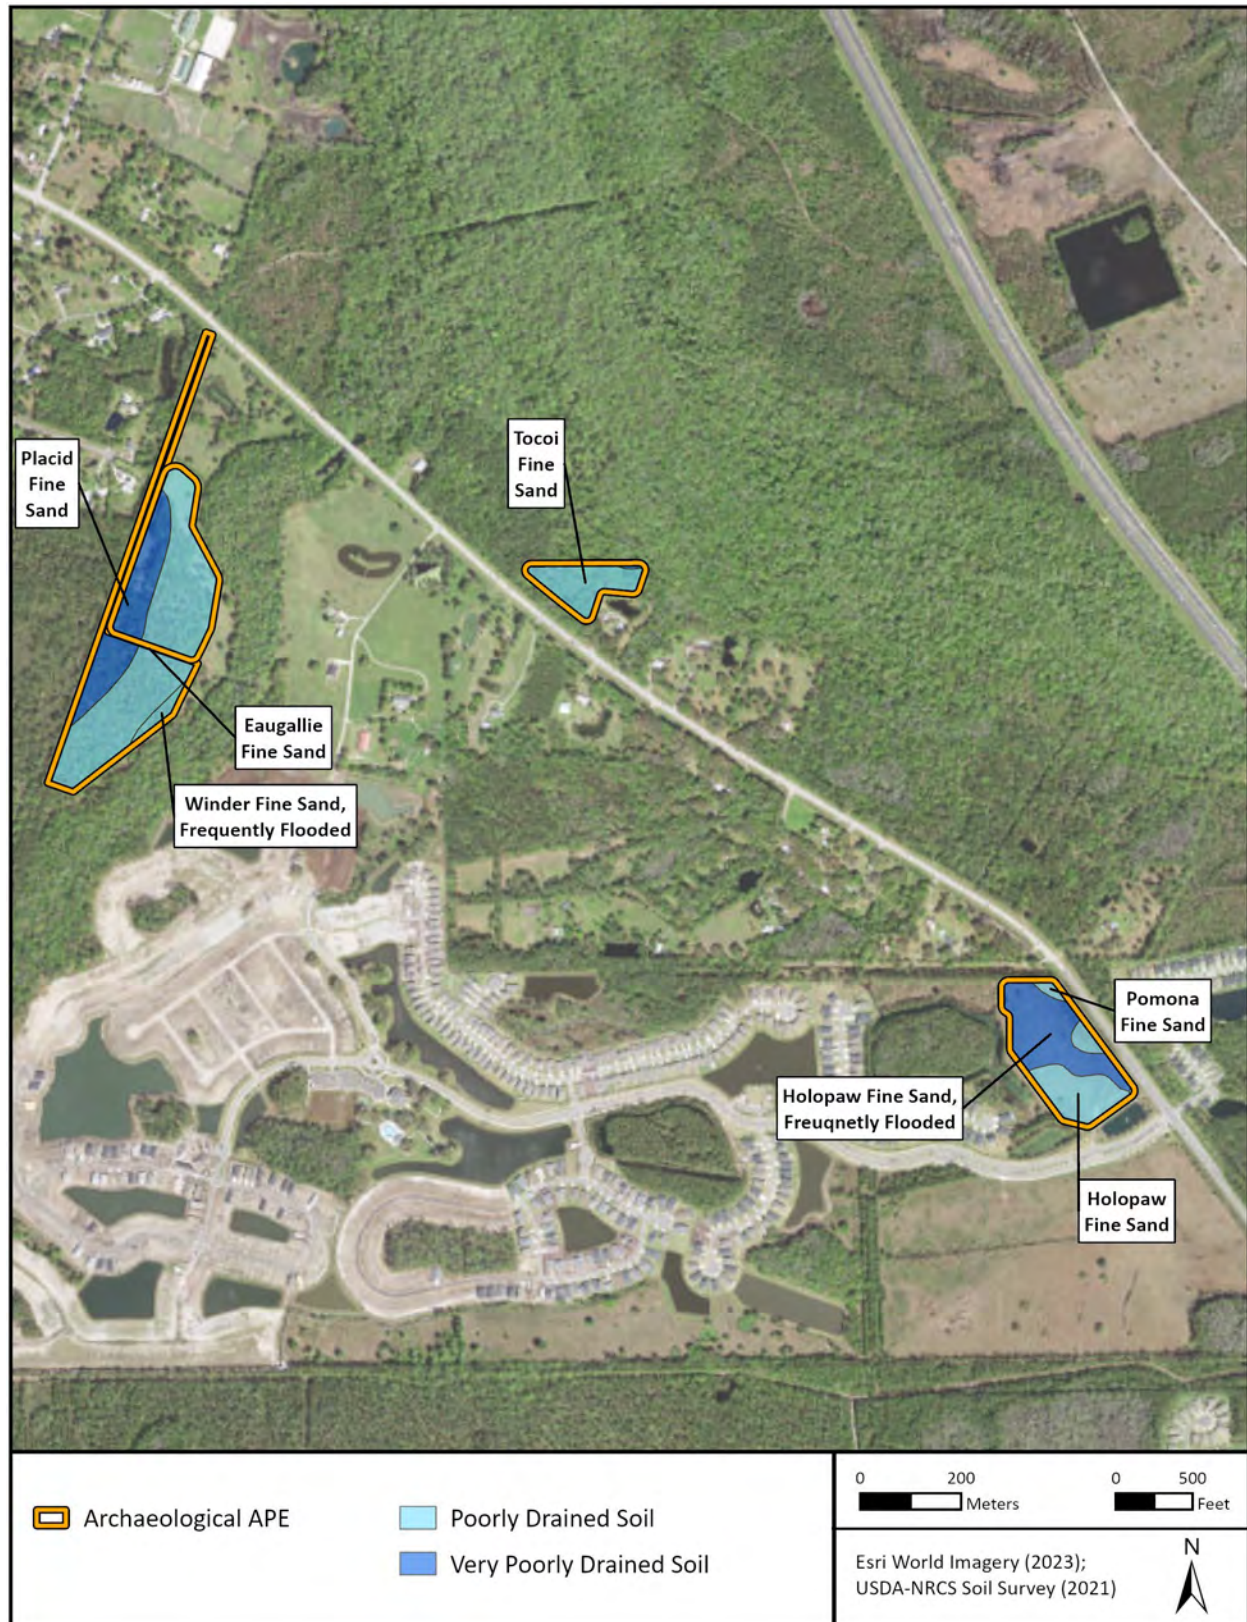
Figure 3. Mapped soils within the APE.

According to Brooks (1981), the APE falls within the Palatka Anomalies Province, which is associated with limestone erosion, stream diversion, and silty deposits from Plio-Pleistocene estuarine and lagoonal environments. Elevations within the APE are approximately 23–26 ft above mean sea level. According to the United States Department of Agriculture (USDA) Natural Resource Conservation Service (NRCS) online Web Soil Survey database (USDA NRCS 2023), mapped soils within the APE consist of very poorly drained Holopaw, Placid, and Winder fine sands, and poorly drained EauGallie, Pomona, and Toco fine sands (**Figure 3**).

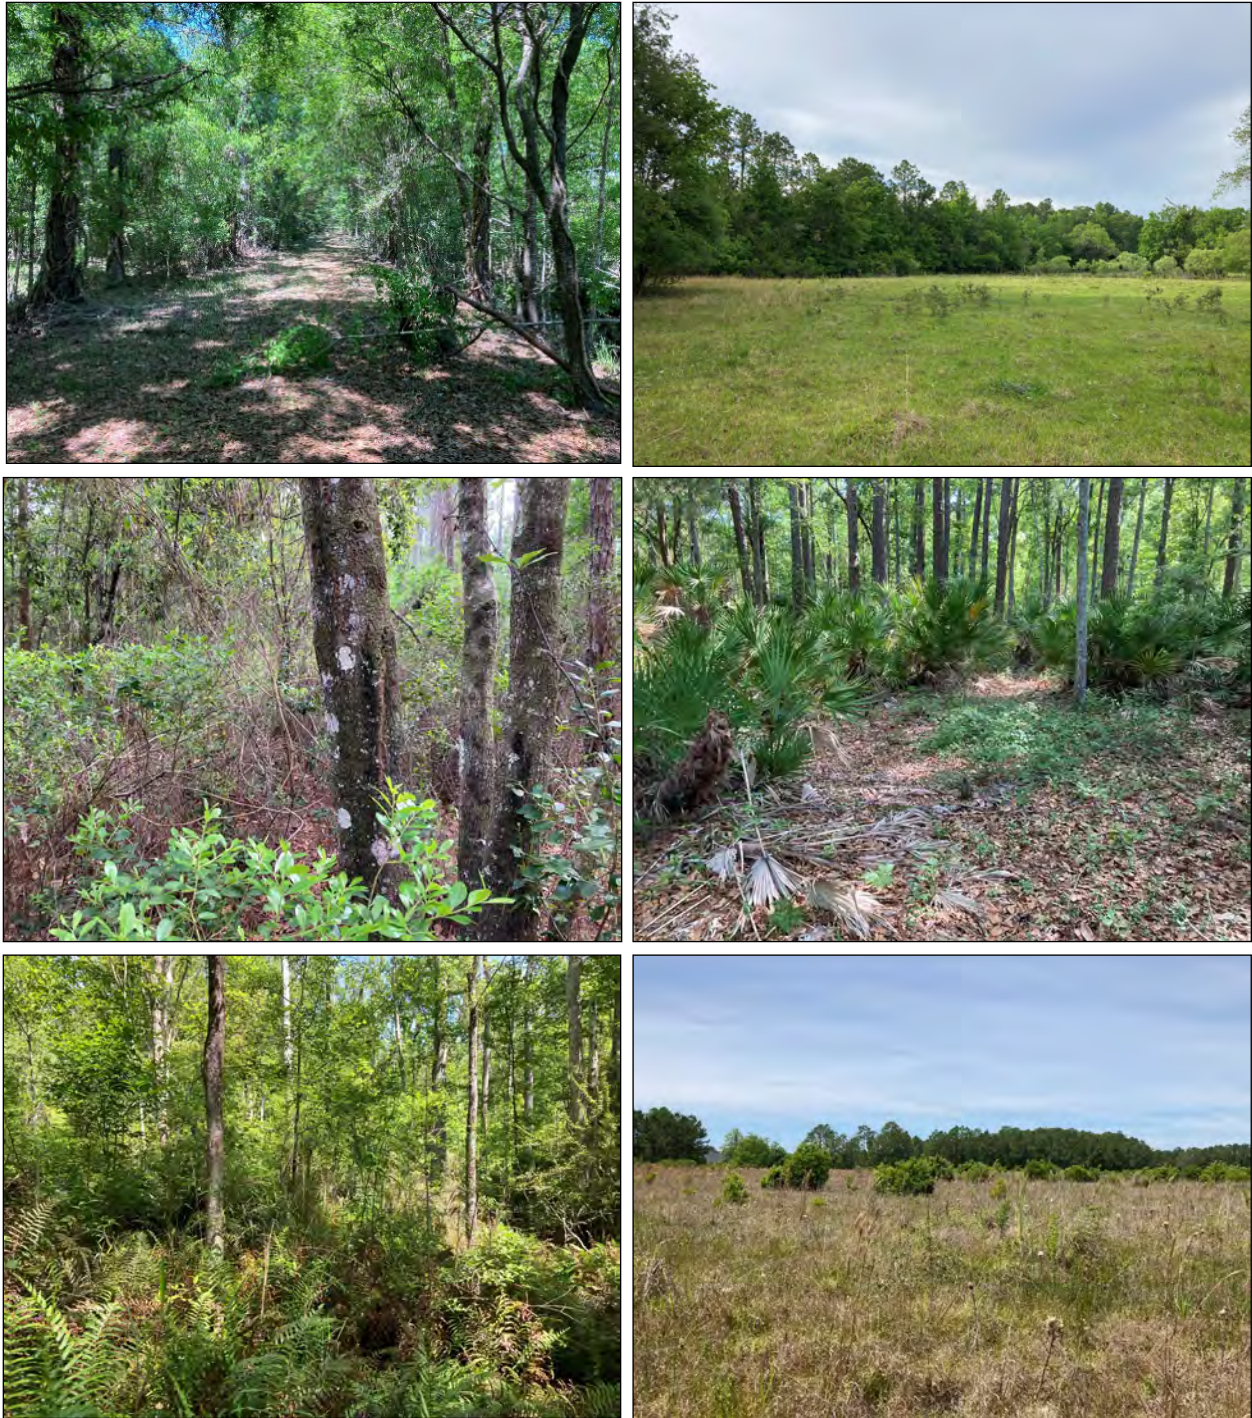
The APE is west of St. Augustine, Florida, in an area characterized by wooded parcels with sporadic marsh and swamp, scattered residential development, and cleared but undeveloped parcels (**Figure 10**). In total, 19 shovel tests were excavated throughout the APE and two no-dig points were marked where testing was not possible due to water inundation at the surface (**Figure 11**). Results of the archaeological testing in each location are discussed below. An FDHR survey log sheet is provided in **Attachment 1**.

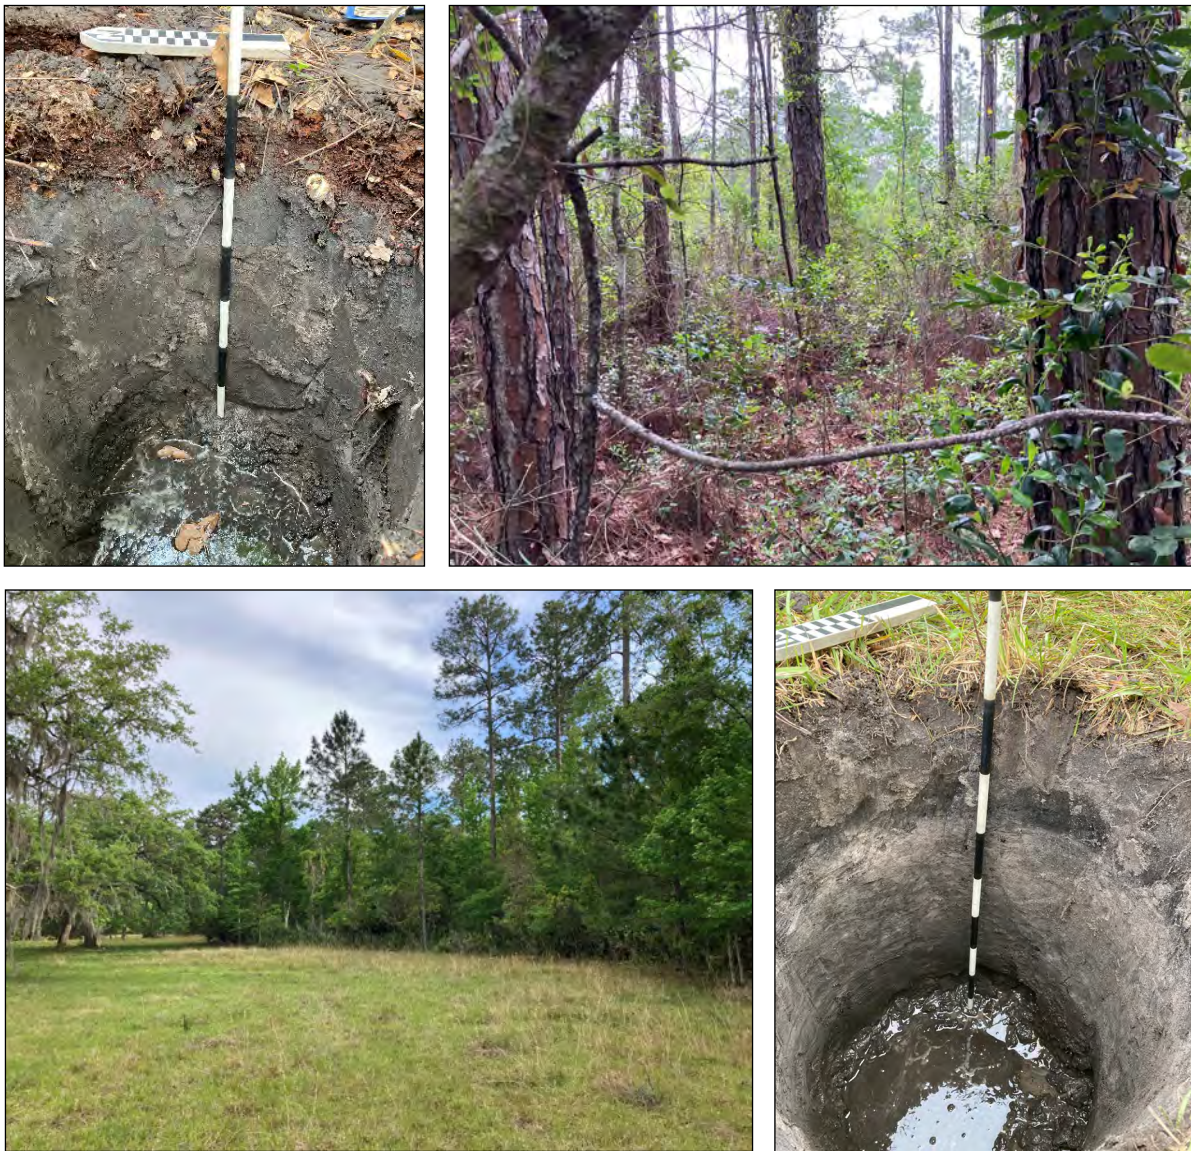
A typical soil profile within Pond 2C consists of black (10YR 2/1) sandy loam from 0 to 40 cmbs (Stratum I), over gray (10YR 5/2) sand from 40 to 70 cmbs (Stratum II) (**Figure 12**). Shovel tests within Pond 2C terminated due to water inundation at a maximum depth of 70 cmbs.

A typical soil profile within Pond 2C consists of black (7.5YR 2.5/1) sandy loam from 0 to 20 cmbs (Stratum I), over gray (7.5YR 5/1) sand from 20 to 70 cmbs (Stratum II), above black (7.5YR 2.5/1) sand from 70 to 80 cmbs (Stratum III) (see **Figure 12**). Shovel tests within Pond 2C terminated due to water inundation at a maximum depth of 80 cmbs.

No artifacts were observed, and no archaeological sites or occurrences were identified; no further archaeological survey is recommended for the Easement/Flood Compensation Area.

No artifacts were observed, and no archaeological sites or occurrences were identified; no further archaeological survey is recommended for Pond 2C.

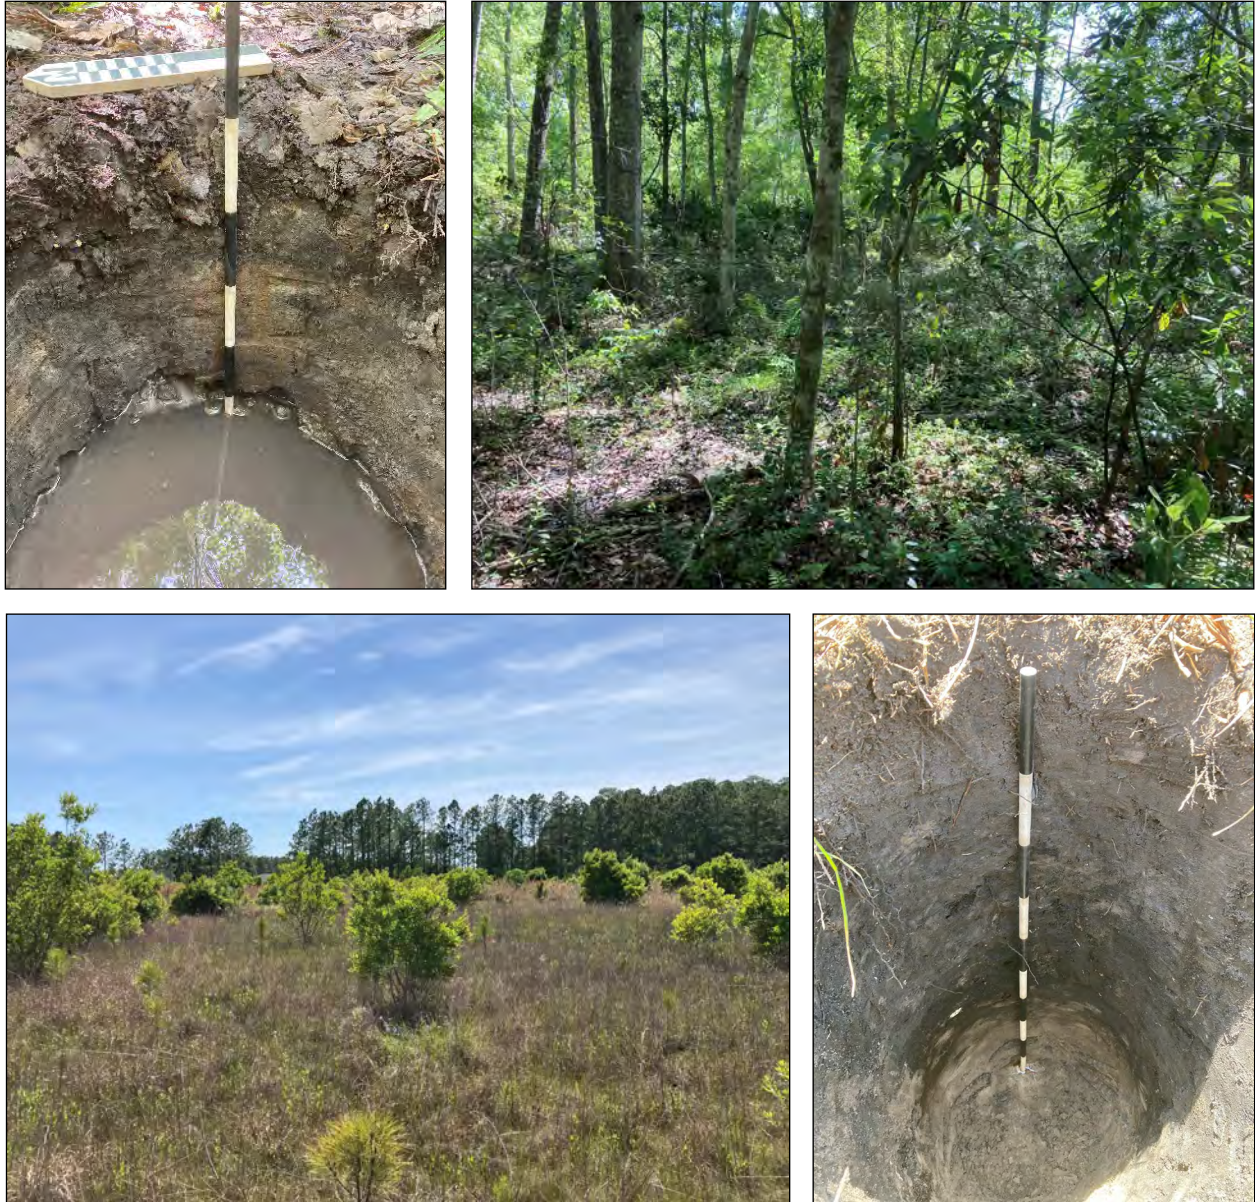
Figure 13. Representative views of the APE within Ponds 3C and 4C. Top left: typical soil profile within Pond 3C. Top right: environmental overview within Pond 3C, view east. Bottom left: environmental overview within Pond 4C, view west. Bottom right: typical soil profile within Pond 4C.

A typical soil profile within Pond 3C consists of reddish black (7.5R 2.5/1) loam from 0 to 10 cmbs (Stratum I), over black (10YR 2/2) sandy loam from 10 to 15 cmbs (Stratum II), above dark gray (10YR 4/1) sand mottled with gray (10YR 4/3) sand from 15 to 40 cmbs (Stratum III), over dark gray (10YR 4/1) sand from 40 to 60 cmbs (Stratum IV) (**Figure 13**). Shovel tests within Pond 3C terminated due to water inundation at a maximum depth of 60 cmbs.

A typical soil profile within Pond 4C consists of black (10YR 2/1) loam from 0 to 10 cmbs (Stratum I), over very dark grey (10YR 2/2) sand from 10 to 40 cmbs (Stratum II), above black (10YR 2/1) sand mottled with gray (10YR 5/1) sand from 40 to 80 cmbs (Stratum III), over gray (10YR 6/1) sand from 80 to 100 cmbs (Stratum IV) (**Figure 13**). Shovel tests within Pond 4C terminated due to water inundation or reaching a maximum depth of 100 cmbs.

No artifacts were observed, and no archaeological sites or occurrences were identified; no further archaeological survey is recommended for Pond 3C.

No artifacts were observed, and no archaeological sites or occurrences were identified; no further archaeological survey is recommended for Pond 4C.

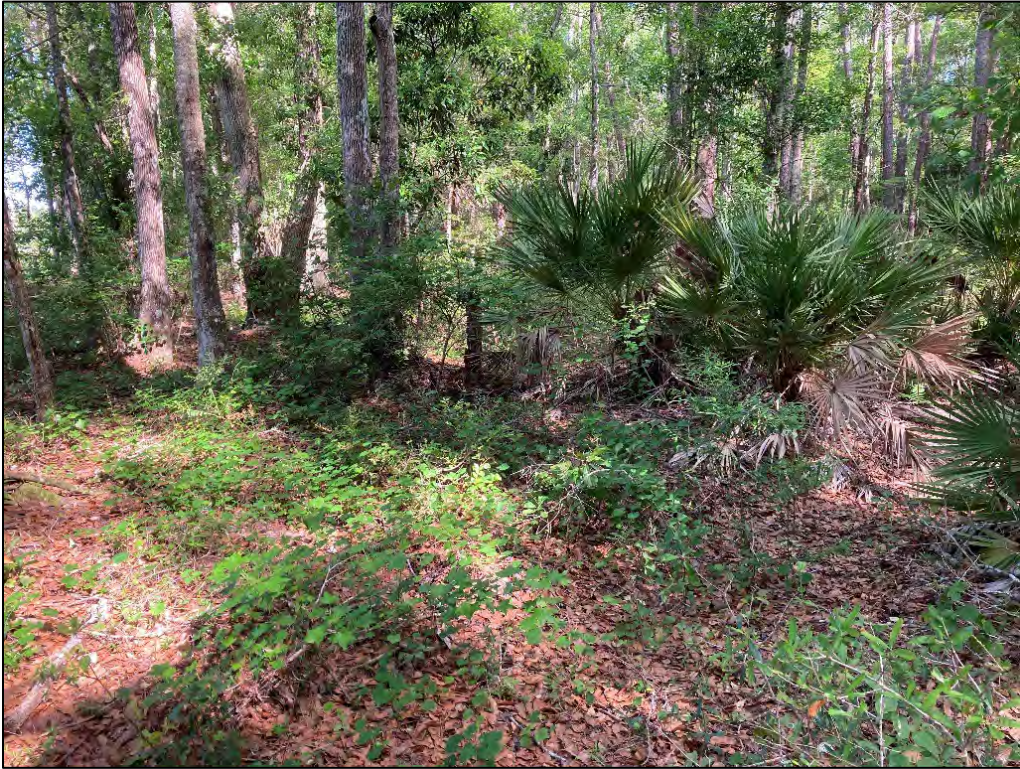
Figure 1. Resource 8SJ04043. Camera facing north.

During background research it was discovered that one previously recorded resource was demolished or removed since the original forms were recorded with the FMSF (**Table 1**). Photographs of the lots as recorded for this project are enclosed at the end of this letter.

Resource	Name/Address	Resource Type / Style	Year Built	NRHP Recommendation
<i>Previously Recorded</i>				
8SJ04043	4125 SR 16	Demolished/Frame Vernacular	c. 1938	Ineligible
