**CONTAMINATION SCREENING  
EVALUATION REPORT**

**SR 5 (US 17) (North Main Street) from New Berlin Road to Max Leggett Parkway  
Jacksonville, Duval County, Florida**

**Financial Project Identification (FPID) No: 209411-8-32-01 and 209411-9-32-01**

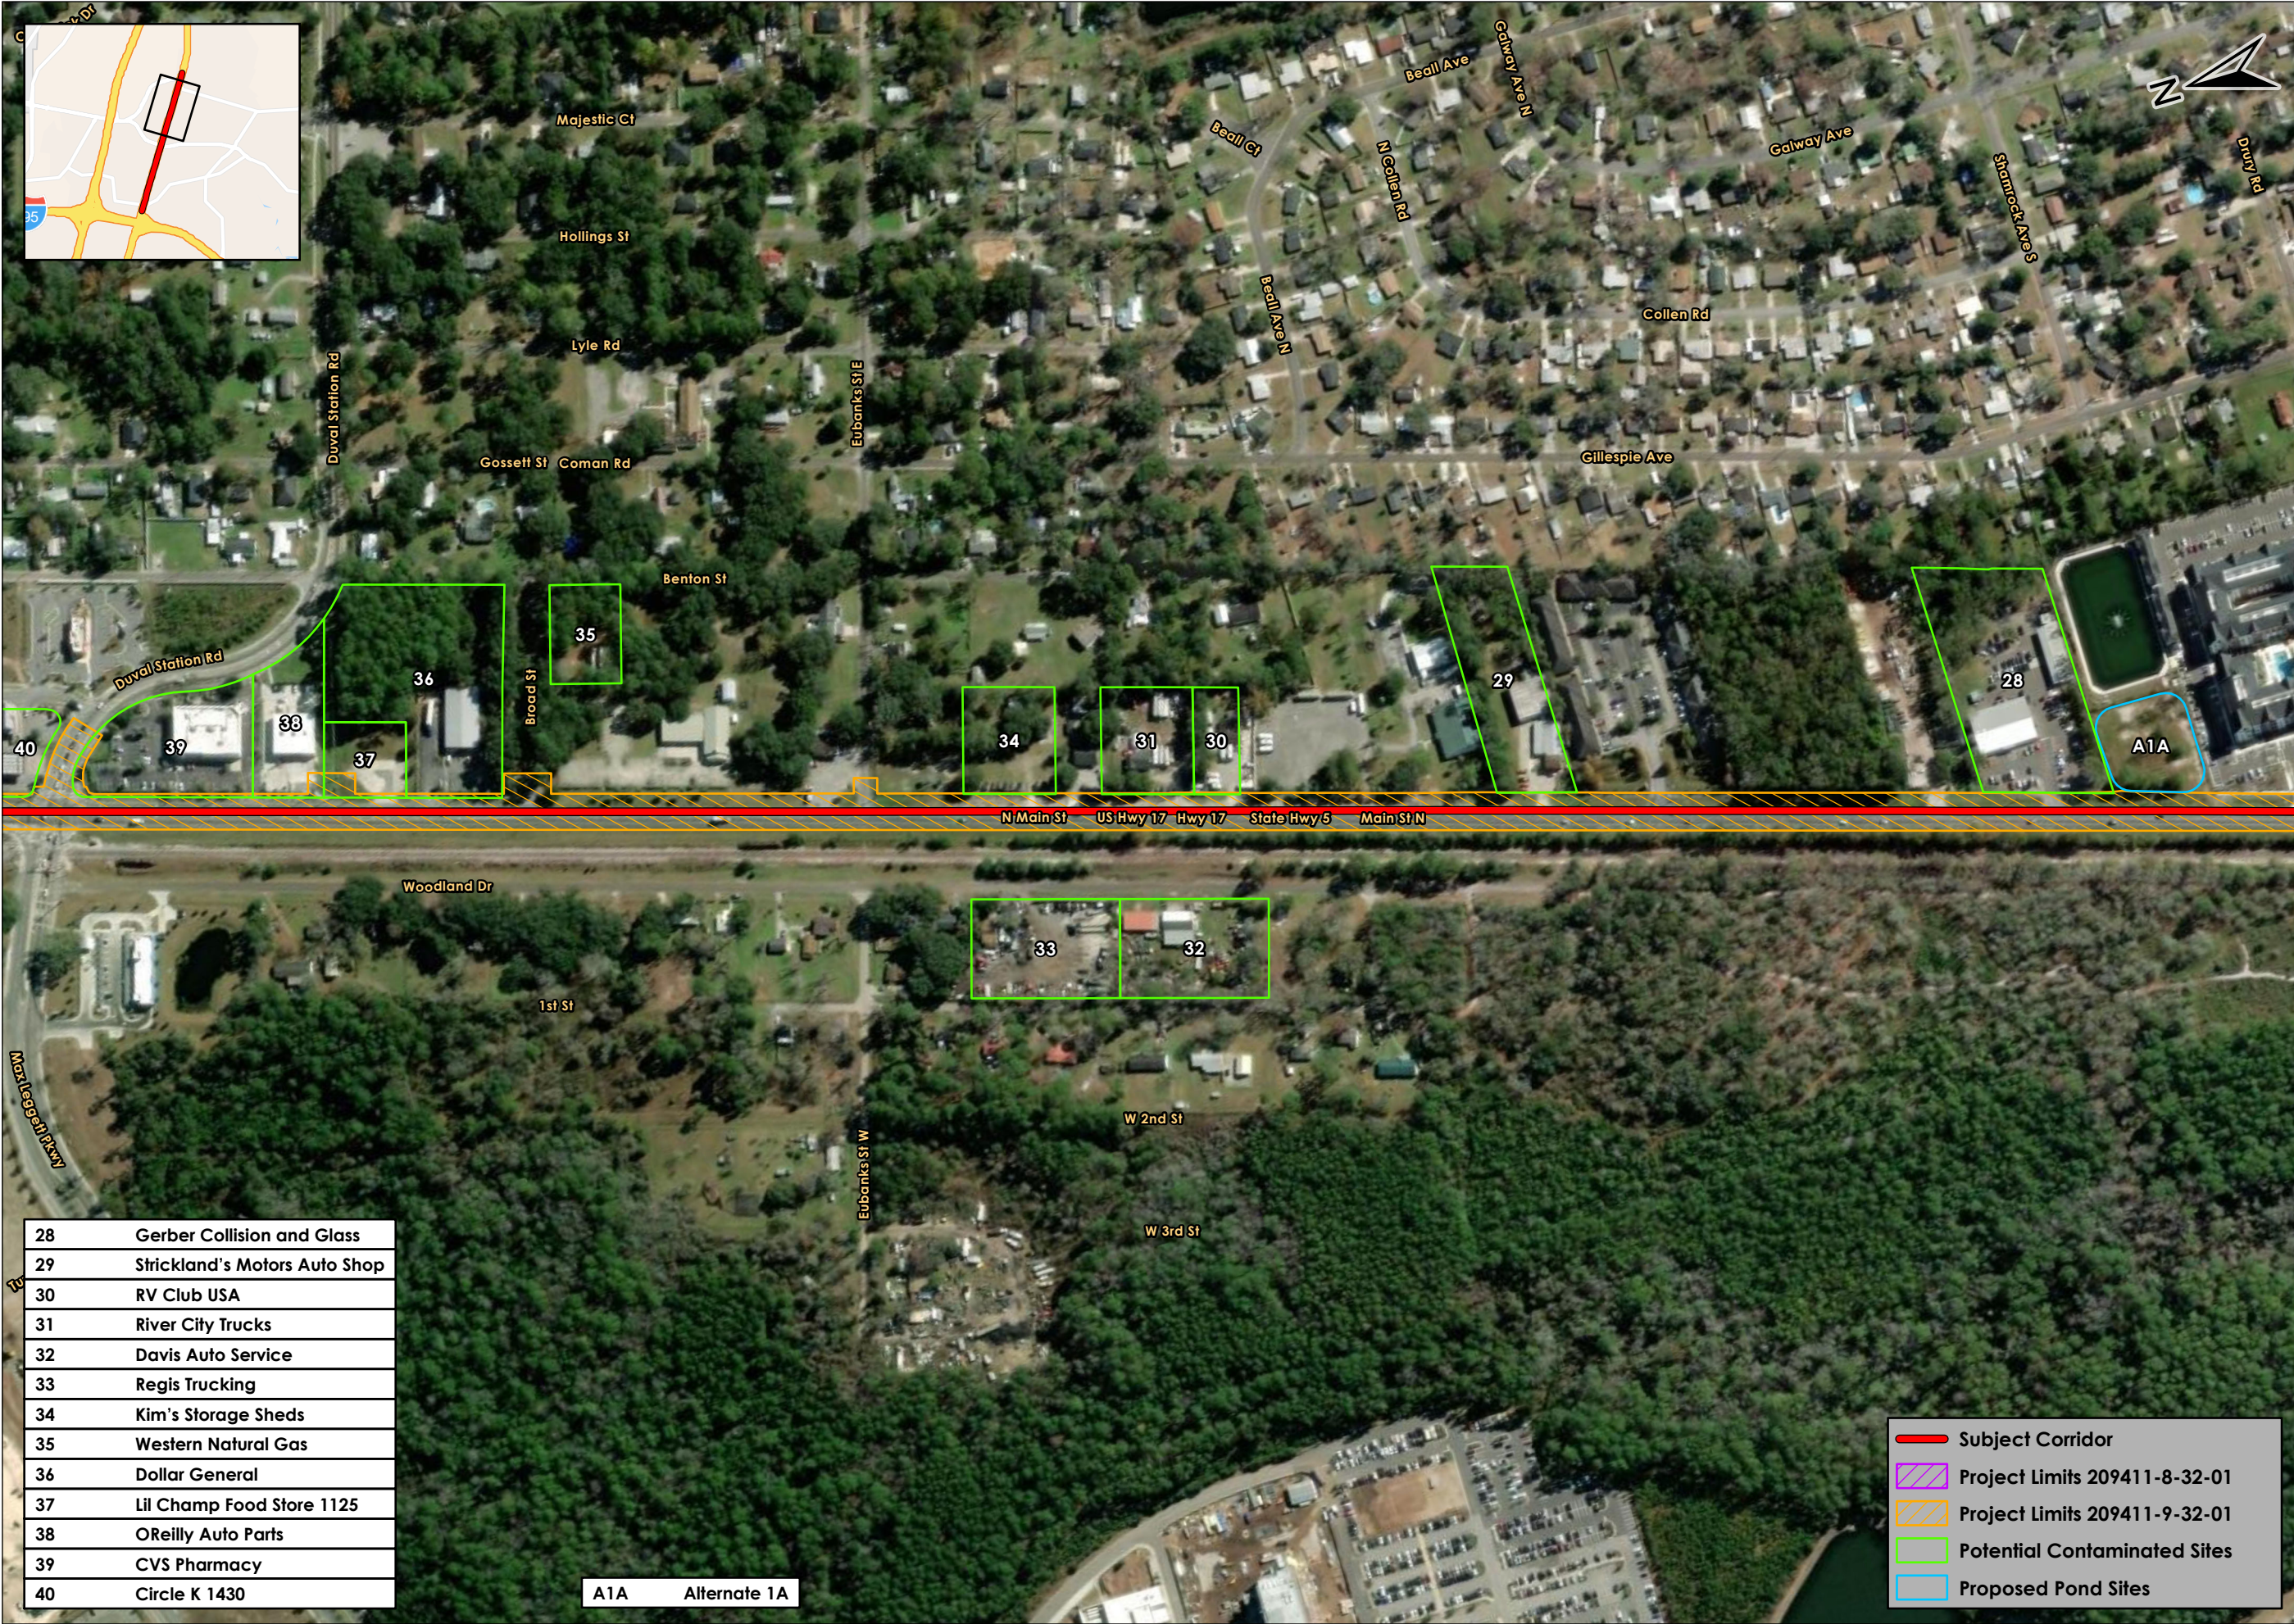
2-3

| 28 | Gerber Collision and Glass |
| 29 | Strickland's Motors Auto Shop |
